Site Visit Report

Date:	February 2, 2017	Prepared By:	Michael Wilkinson
Client:	Grafton Planning Board	Arrived on site:	11:05 AM
Project:	Gristmill Village	Left site:	11:35 AM
Contractor:	DiPilato Construction Co, Inc.	Site Conditions:	Residual Snow
Contractor Contact:	Nick DiPilato	Weather:	34° Partly Cloudy

GEI was on site to witness drainage installation on Millstone Drive as part of the Gristmill Village subdivision. Upon arrival, I met with Nick DiPilato to review the work. Today, the following was observed:

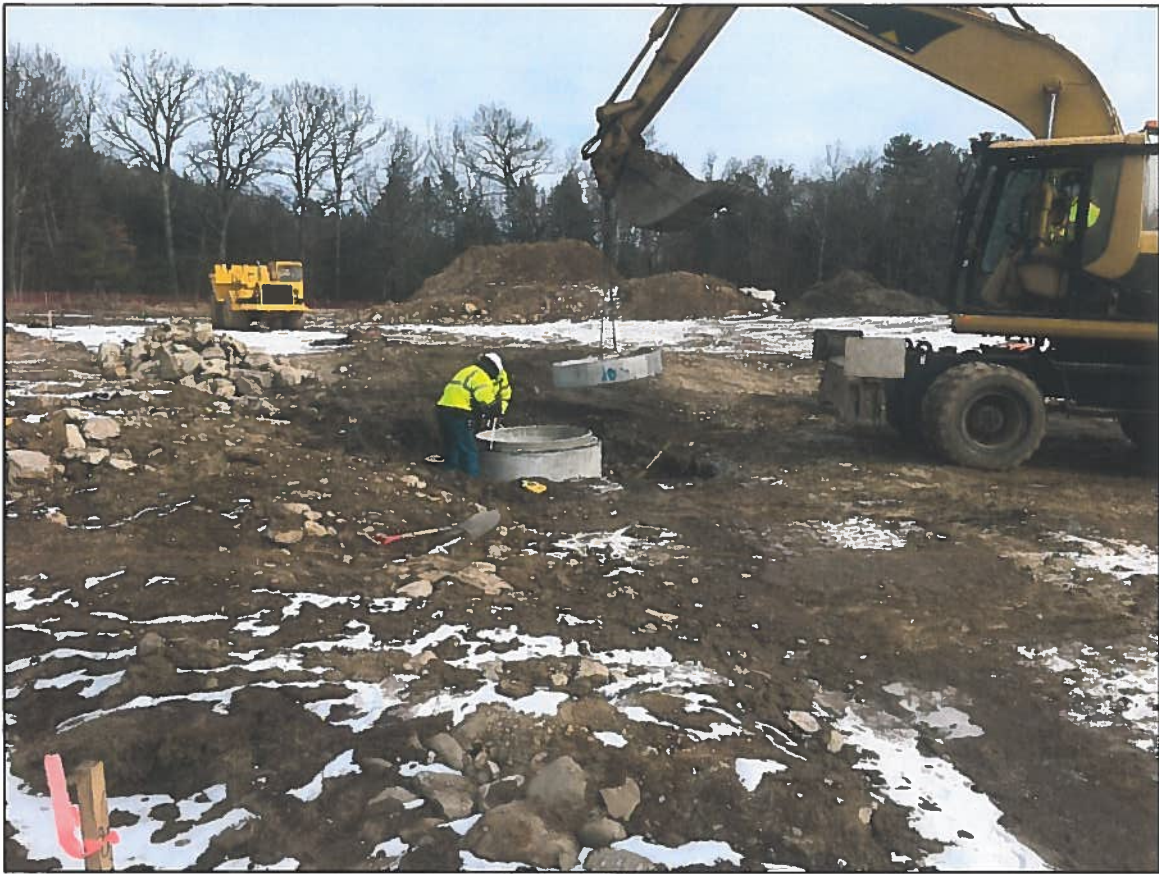
Photo 1: Installation of CB-5 with Kent seal between sections.

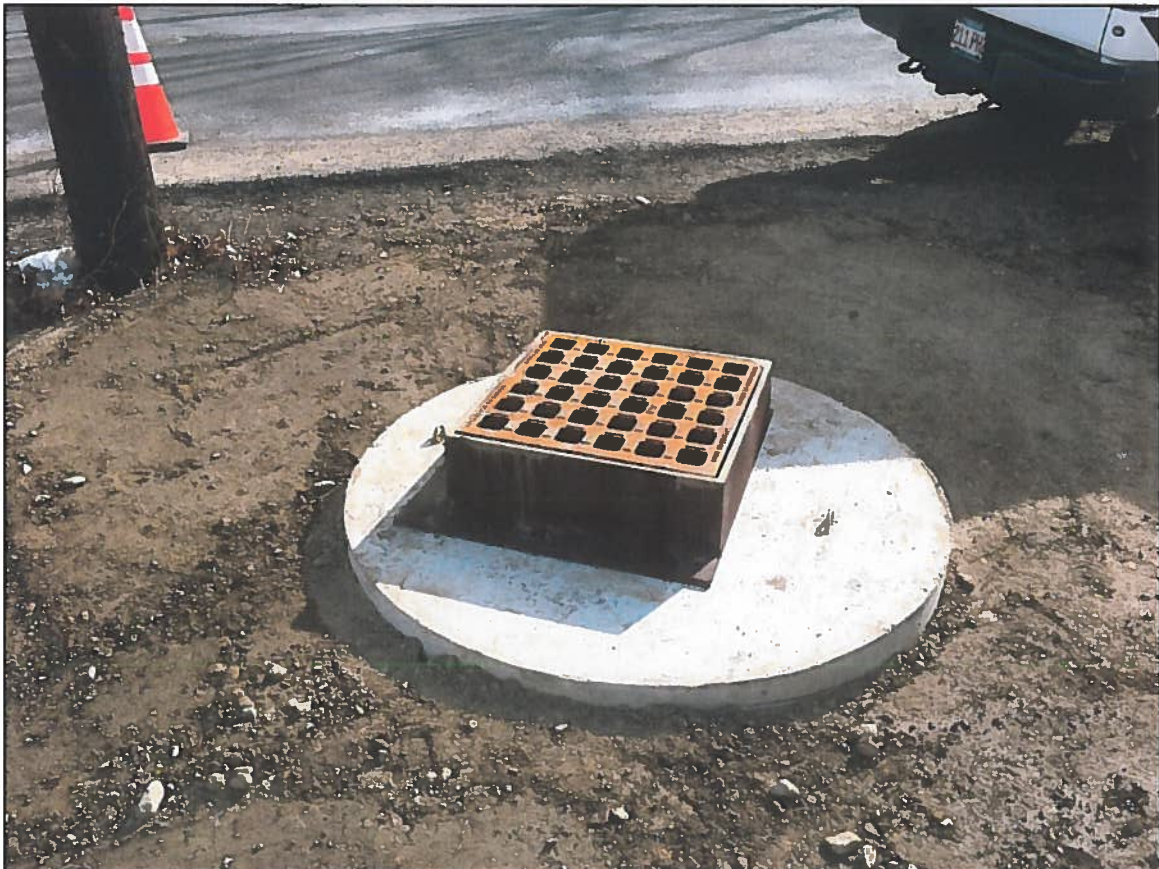
Photo 2: Frame and grate on CB-1.
