Site Visit Repor

01/25/17

Grafton Planning Board Gristmill Village

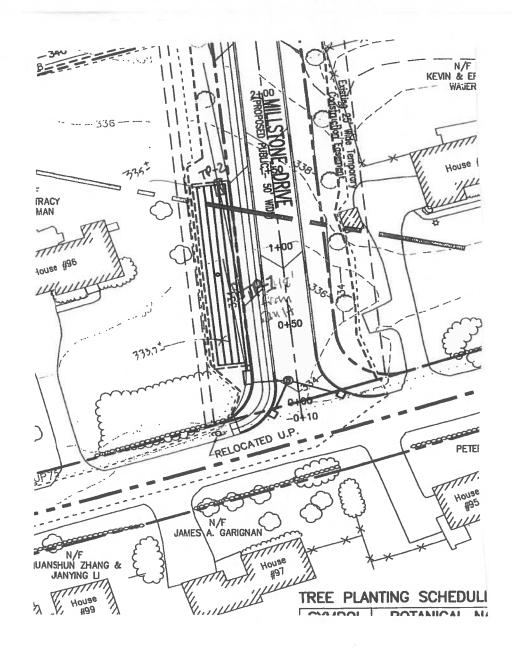
GEI was on-site to witness deep hole test pits at the location of the subsurface recharge system located at Millstone Drive, station 1+00+/- left. J.M. Grenier Associates Inc. located the test pits, which were excavated by DiPilato Construction Company, Inc. with an excavator. The test pits were evaluated by John Grenier of J.M. Grenier Associates Inc. It is the responsibility of the design engineer to verify compliance with the MassDEP Stormwater Handbook and Town of Grafton requirements relative to test pit locations and depth. Two test pits were evaluated; the findings are presented below. A sketch of the locations is also presented below.
