# Site Visit Report

<b>Date:</b>	09/15/15	<b>Prepared By:</b>	Jeffrey Walsh
<b>Client:</b>	Grafton Planning Board	<b>Arrived on site:</b>	1:55 PM
<b>Project:</b>	Clearview Estates	<b>Left site:</b>	3:40 PM
<b>Contractor:</b>	Connorstone Engineering, Inc.	<b>Site Conditions:</b>	Damp
<b>Contractor Contact:</b>	Vito Colonna	<b>Weather:</b>	70°, Clear

Clearview Estates

Soil Testing Locations

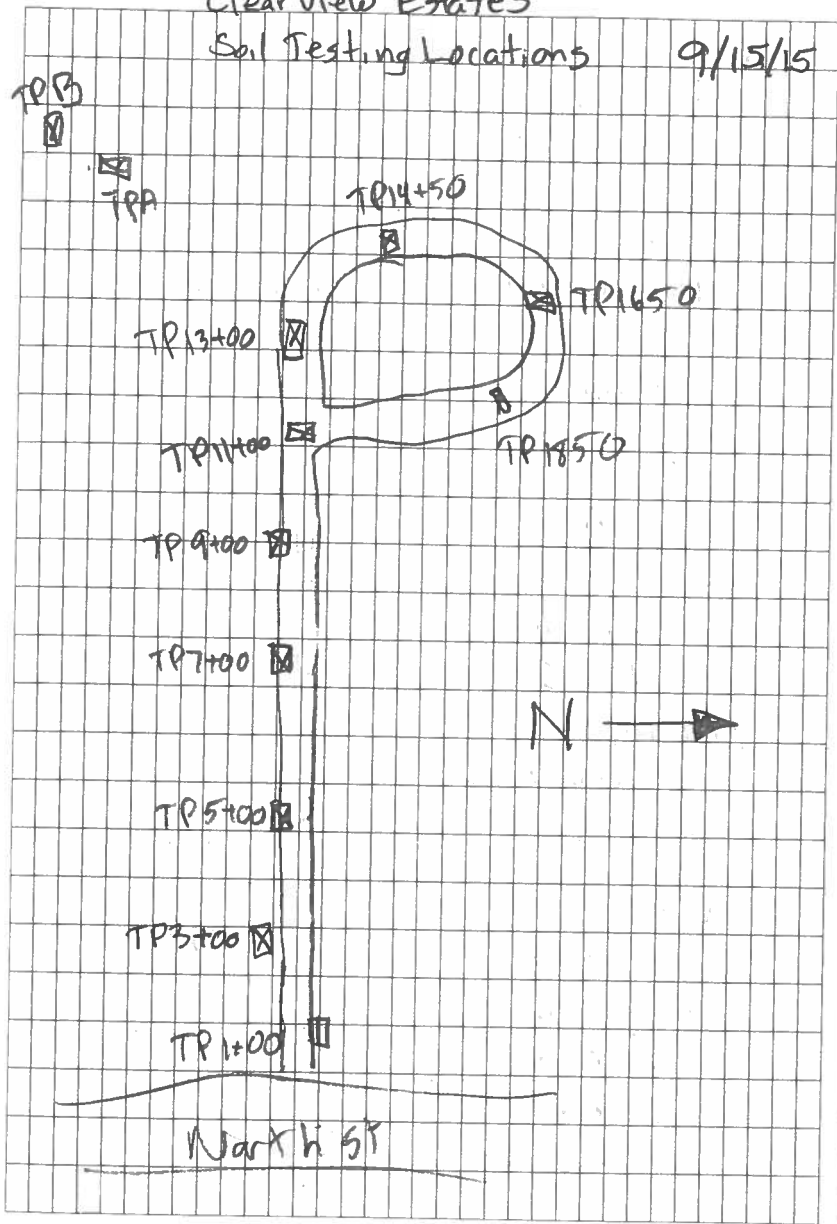
GEI was on-site to witness deep hole test pits along the proposed road and at the anticipated location of a proposed stormwater management facility. Connorstone Engineering, Inc. located the test pits, which were excavated by Baril Construction with a Caterpillar 426 backhoe. The test pits were evaluated by Vito Colonna of Connorstone Engineering, Inc. It is the responsibility of the design engineer to verify compliance with the DEP Stormwater Management Guidelines and Town of Grafton requirements relative to test pit locations and depth. Ten test pits were evaluated along the roadway and two test pits were evaluated at the stormwater management facility. A sketch of the testing locations is attached to this site visit report. The findings of the soil evaluations are presented below.
