Site Visit Report

Date: February 15, 2017
Client: Grafton Planning Board
Project: Gristmill Village
Contractor: DiPilato Construction Co, Inc.
Contractor Contact: Nick DiPilato

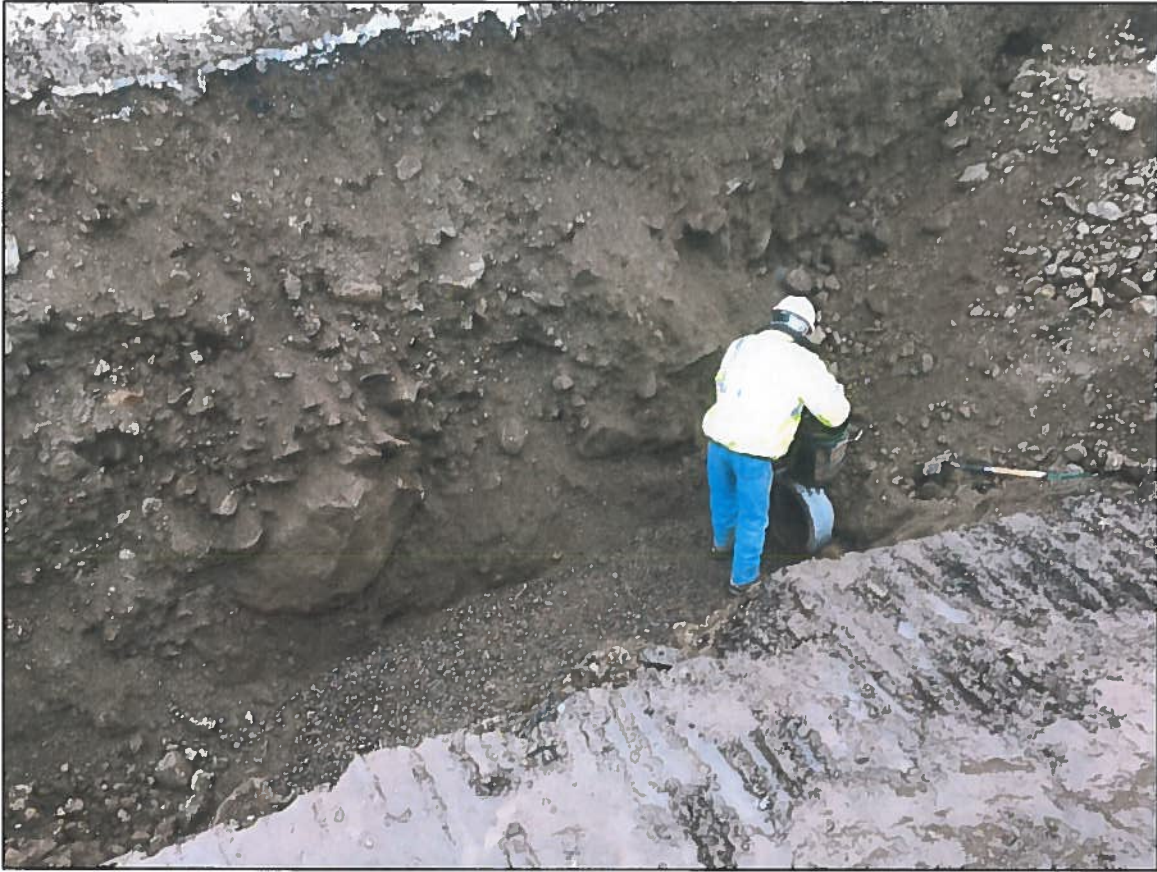
Pipes were bedded on crushed stone set to line and grade with a laser. Pipe joints were sealed with rubber gaskets. The pipe was then backfilled with crushed stone up to the springline and then the stone was chinked up against the pipe. Sorted trench spoil was used for the remaining backfill and was being compacted by a vibratory plate compactor. DiPilato was backfilling pipe as it was being laid.

Photo 1: Open drainage pipe trench with installed bed of crushed stone.
